Therese McAllister Jonathan Barnett John Gross Ronald Hamburger Jon Magnusson

1Introduction

1.1 Purpose and Scope of Study

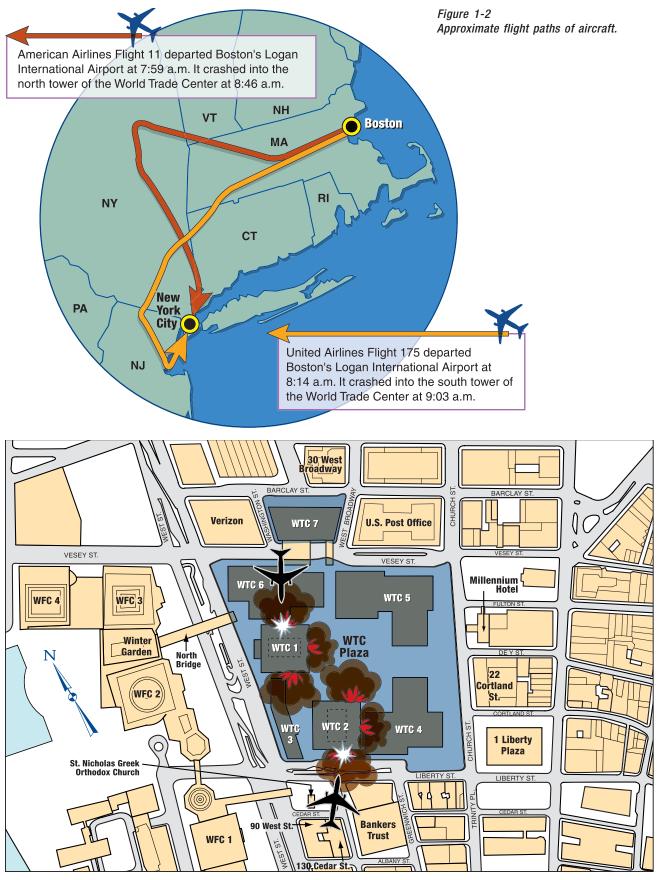
The north tower was struck between floors 94 and 98, with the impact roughly centered on the north face. The south tower was hit between floors 78 and 84 toward the east side of the south face (Figures 1-3 and 1-4). Each plane banked steeply as it was flown into the building, causing damage across multiple floors. According to Government sources, the speed of impact into the north tower was estimated to be 410 knots, or 470 miles per hour (mph), and the speed of impact into the south tower was estimated to be 510 knots, or 590 mph. As the two aircraft impacted the buildings, fireballs erupted (Figure 1-5) and jet fuel spread across the impact floors and down interior shaftways, igniting fires (Figure 1-6). The term fireball is used to describe deflagration, or ignition, of a fuel vapor cloud. As the resulting fires raged throughout the upper floors of the two WTC towers, thousands attempted to evacuate the buildings. It was estimated by the Port Authority that the population of the WTC complex on September 11, 2001, was 58,000 people. This estimate includes the PATH and MTA stations and the Concourse areas. Almost everyone in WTC 1 and WTC 2 who was below the impact areas was able to safely evacuate the buildings, due to the length of time between the impact and collapse of the individual towers.

Figure 1-3 WTC impact locations and resulting fireballs.

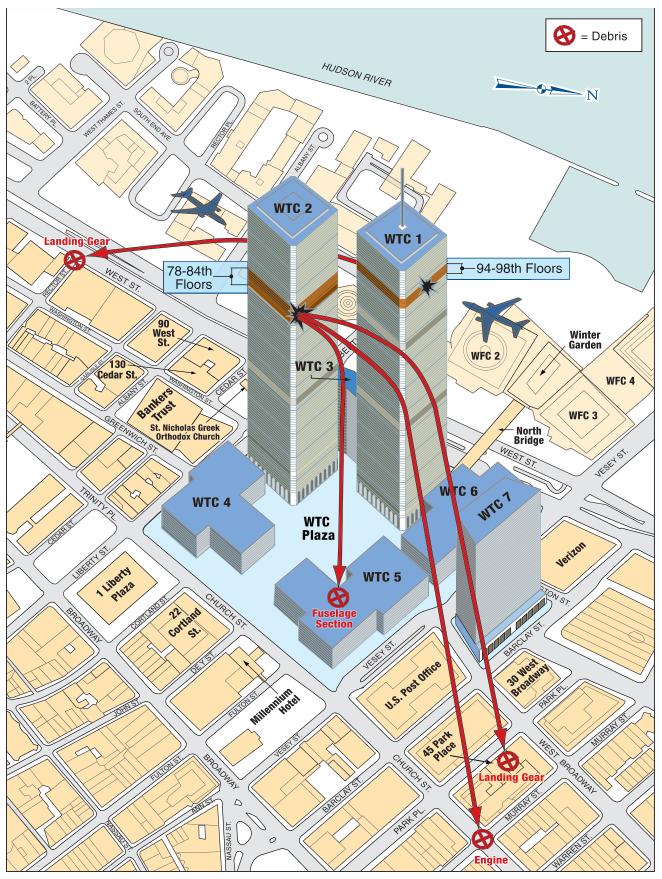
Figure 1-4 Areas of aircraft debris impact.

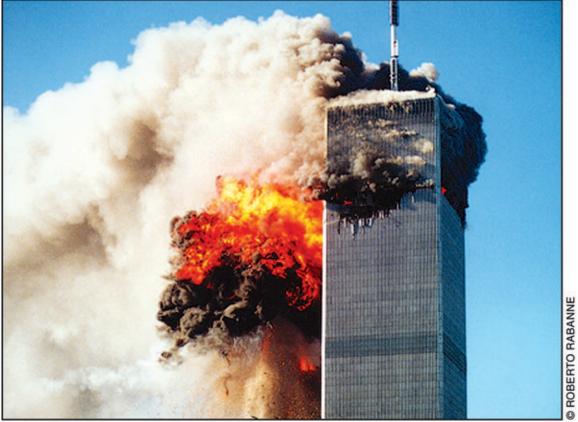
Figure 1-5 Fireball erupts on the north face of WTC 2 as United Airlines Flight 175 strikes the building.

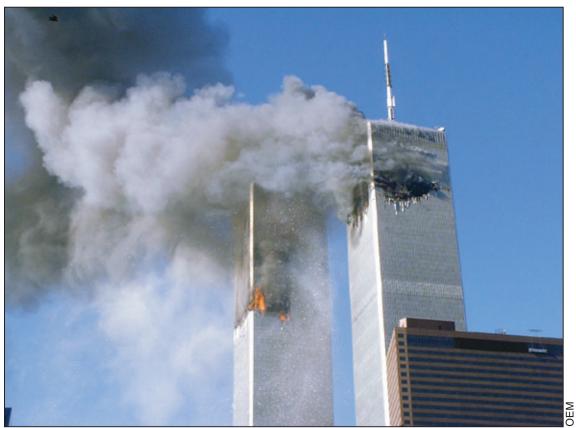
Figure 1-6 View of the north and east faces showing fire and impact damage to both towers.

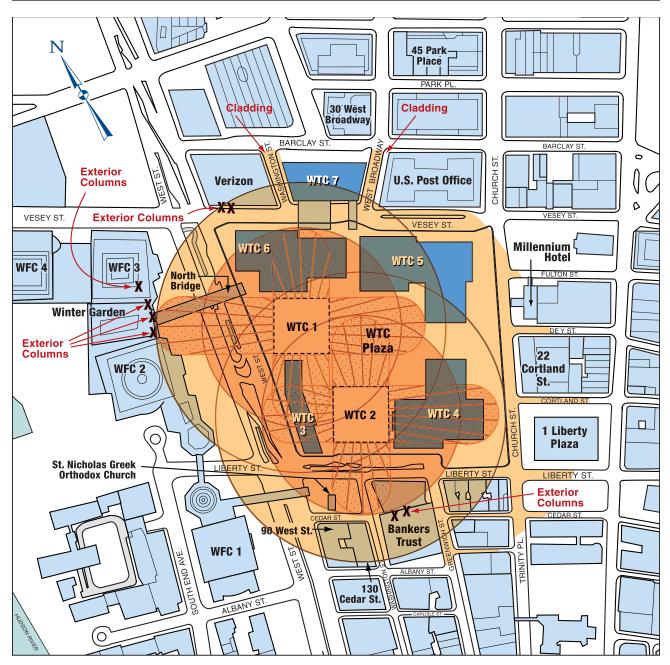
Debris from the collapsing towers, some of it still on fire, rained down on surrounding buildings, causing structural damage and starting new fires (Figure 1-7). The sudden collapse of each tower sent out air pressure waves that spread dust clouds of building materials in all directions for many blocks. The density and pressure of the dust clouds were strong enough to carry light debris and lift or move small vehicles and break windows in adjacent buildings for several blocks around the WTC site. Most of the fires went unattended as efforts were devoted to rescuing those trapped in the collapsed towers. The 22-story Marriott World Trade Center Hotel (WTC 3) was hit by a substantial amount of debris during both tower collapses. Portions of WTC 3 were severely damaged by debris from each tower collapse, but progressive collapse of the building did not occur. However, little of WTC 3 remained standing after the collapse of WTC 1. WTC 4, 5, and 6 had floor contents and furnishings burn completely and suffered significant partial collapses from debris impacts and from fire damage to their structural frames. WTC 7, a 47-story building that was part of the WTC complex, burned unattended for 7 hours before collapsing at 5:20 p.m. The falling debris also damaged water mains around the WTC site at the following locations:

Figure 1-7 Schematic depiction of areas of collapse debris impact, based on aerial photographs and documented damage. Striped areas indicate predominant locations of exterior steel columns. Inner circles indicate approximate radius of exterior steel columns and other heavy debris. Outer circles indicate approximate radius of aluminum cladding and other lighter debris. Heavy Xs show where exterior steel columns were found outside the predominate debris areas.

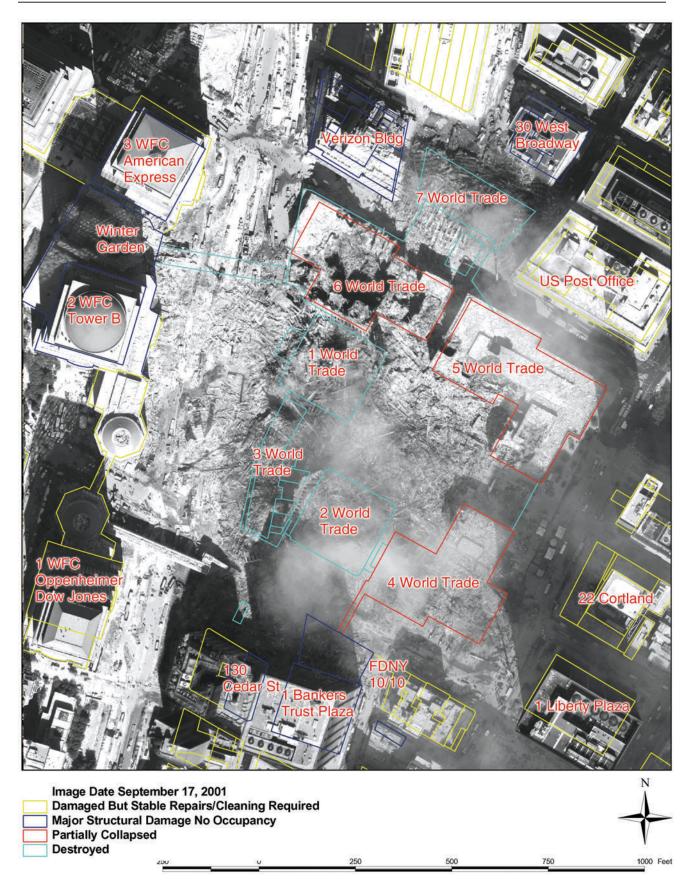
Figure 1-9B Satellite photograph of the WTC site taken after the attacks.
